Virginia Tech Hampton Roads Agricultural Research and Extension Center

Relocation Planning Study

15 December 2022

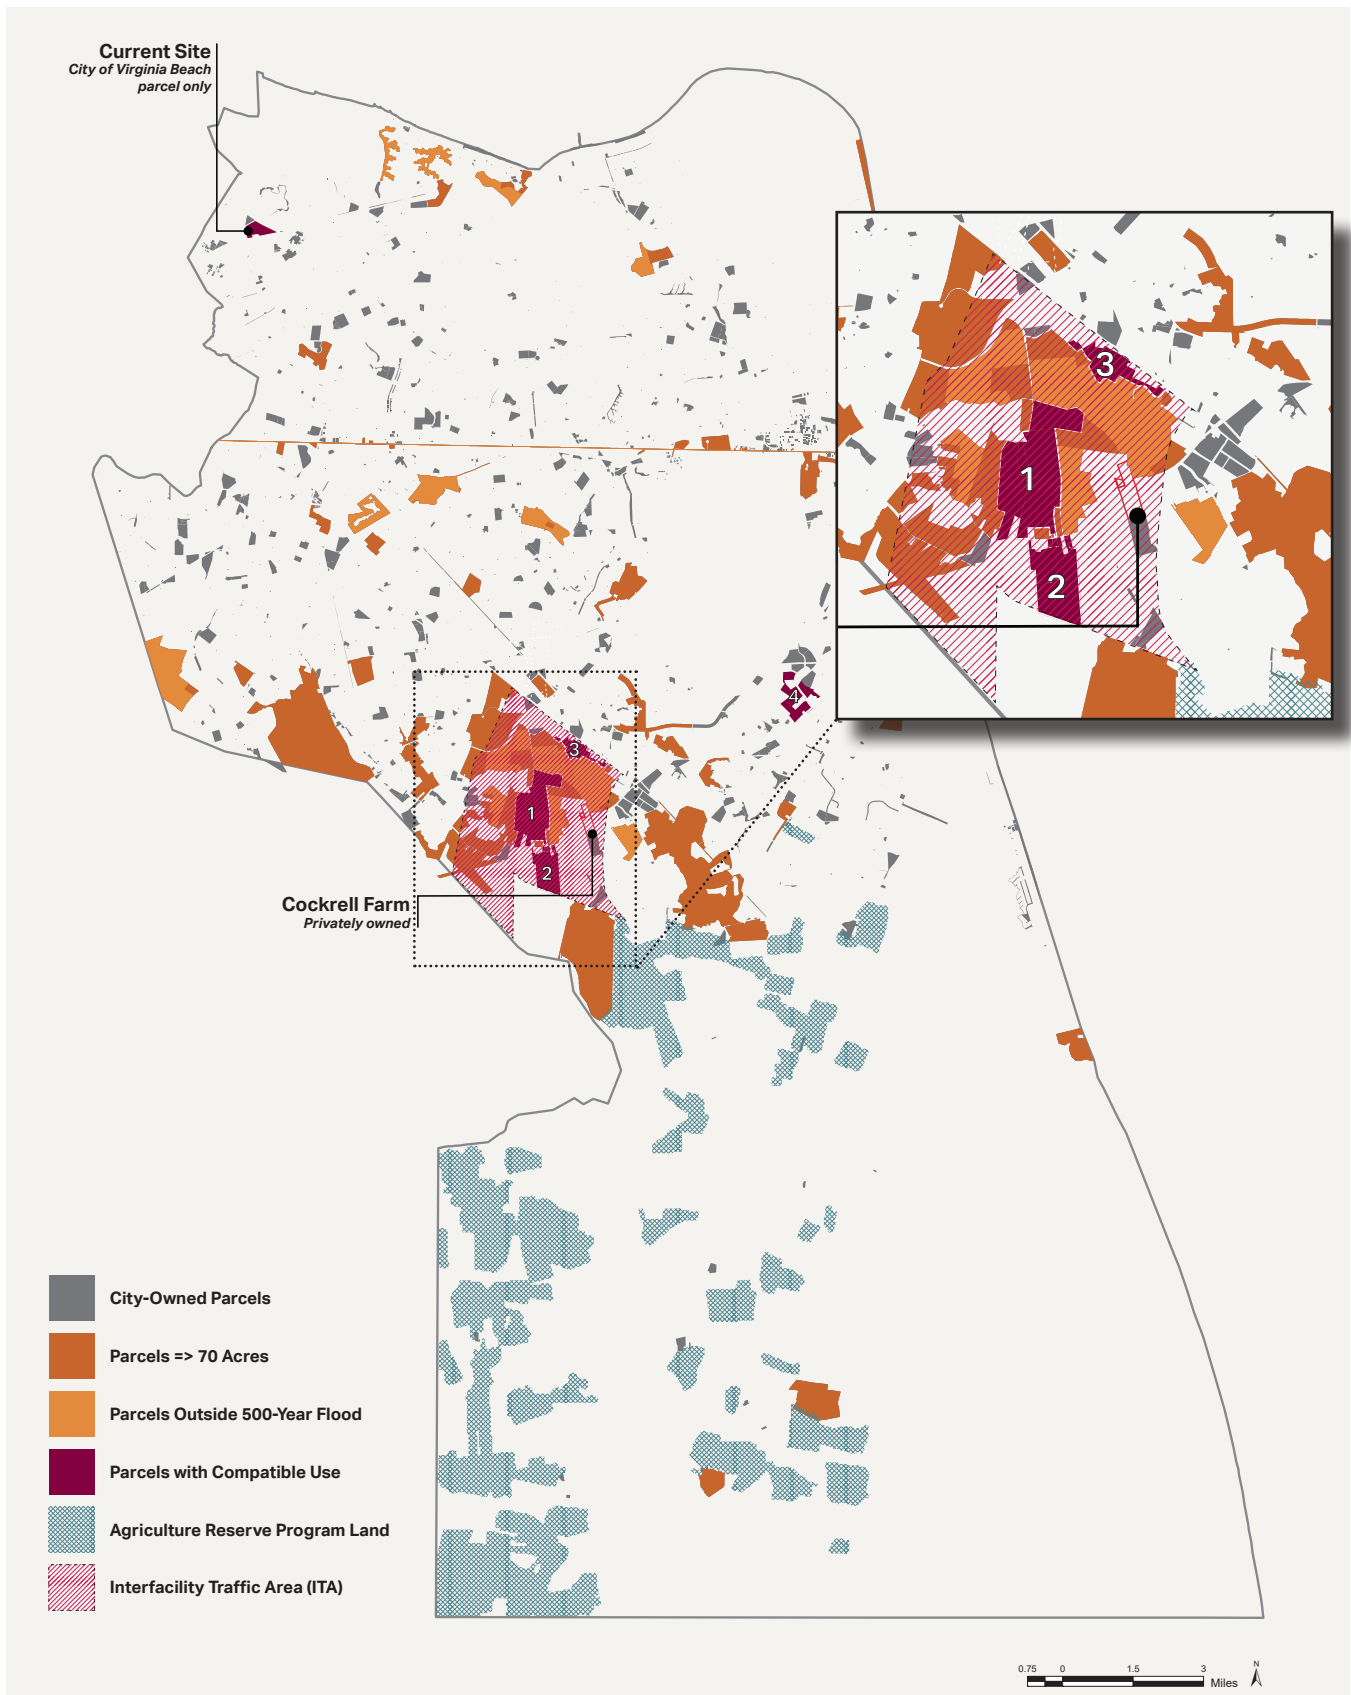
Figure 24. Site Selection. Parcels shown in gray are City of Virginia Beach-owned parcels. Using the defined parameters, four sites, indicated in maroon, were identified for additional analysis.

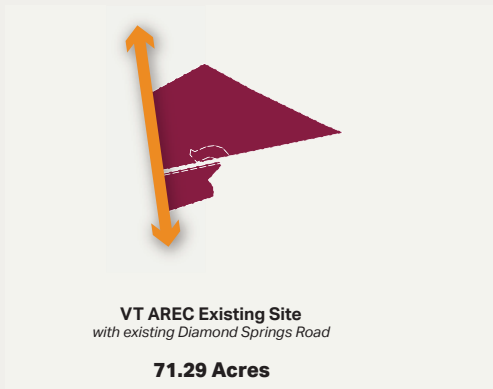
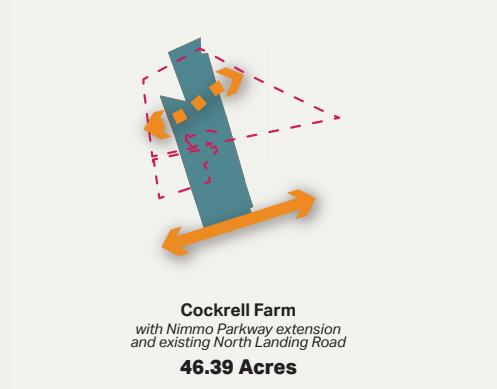
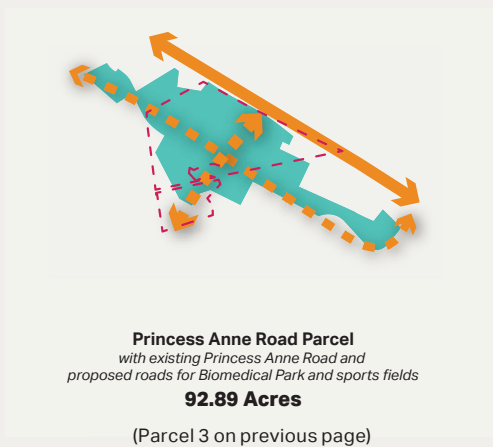
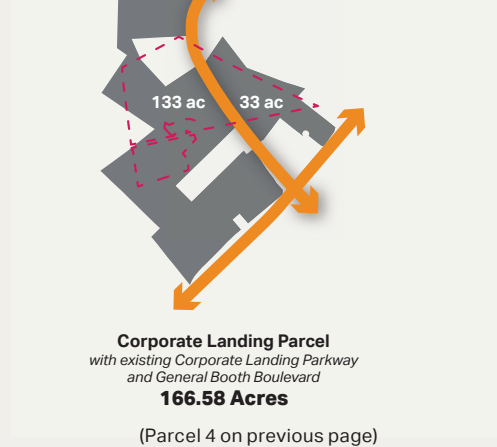
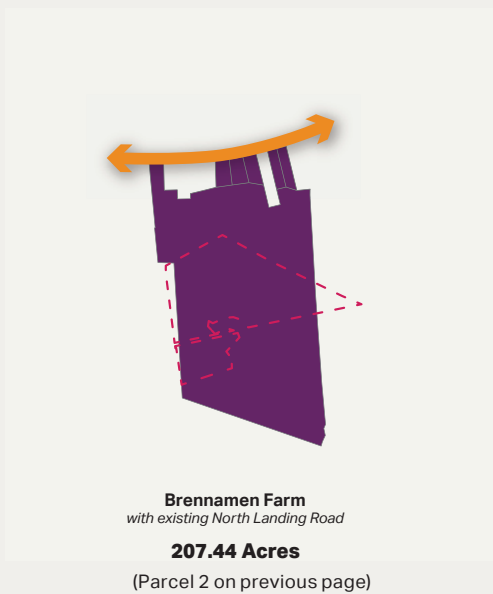
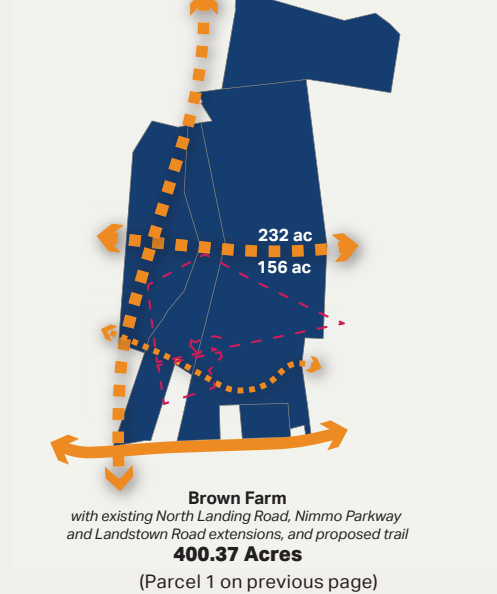
Figure 25. Selected Parcels Diagram. Four parcel options were returned via GIS analysis and a fifth, Cockrell Farm, was suggested by the City of Virginia Beach.

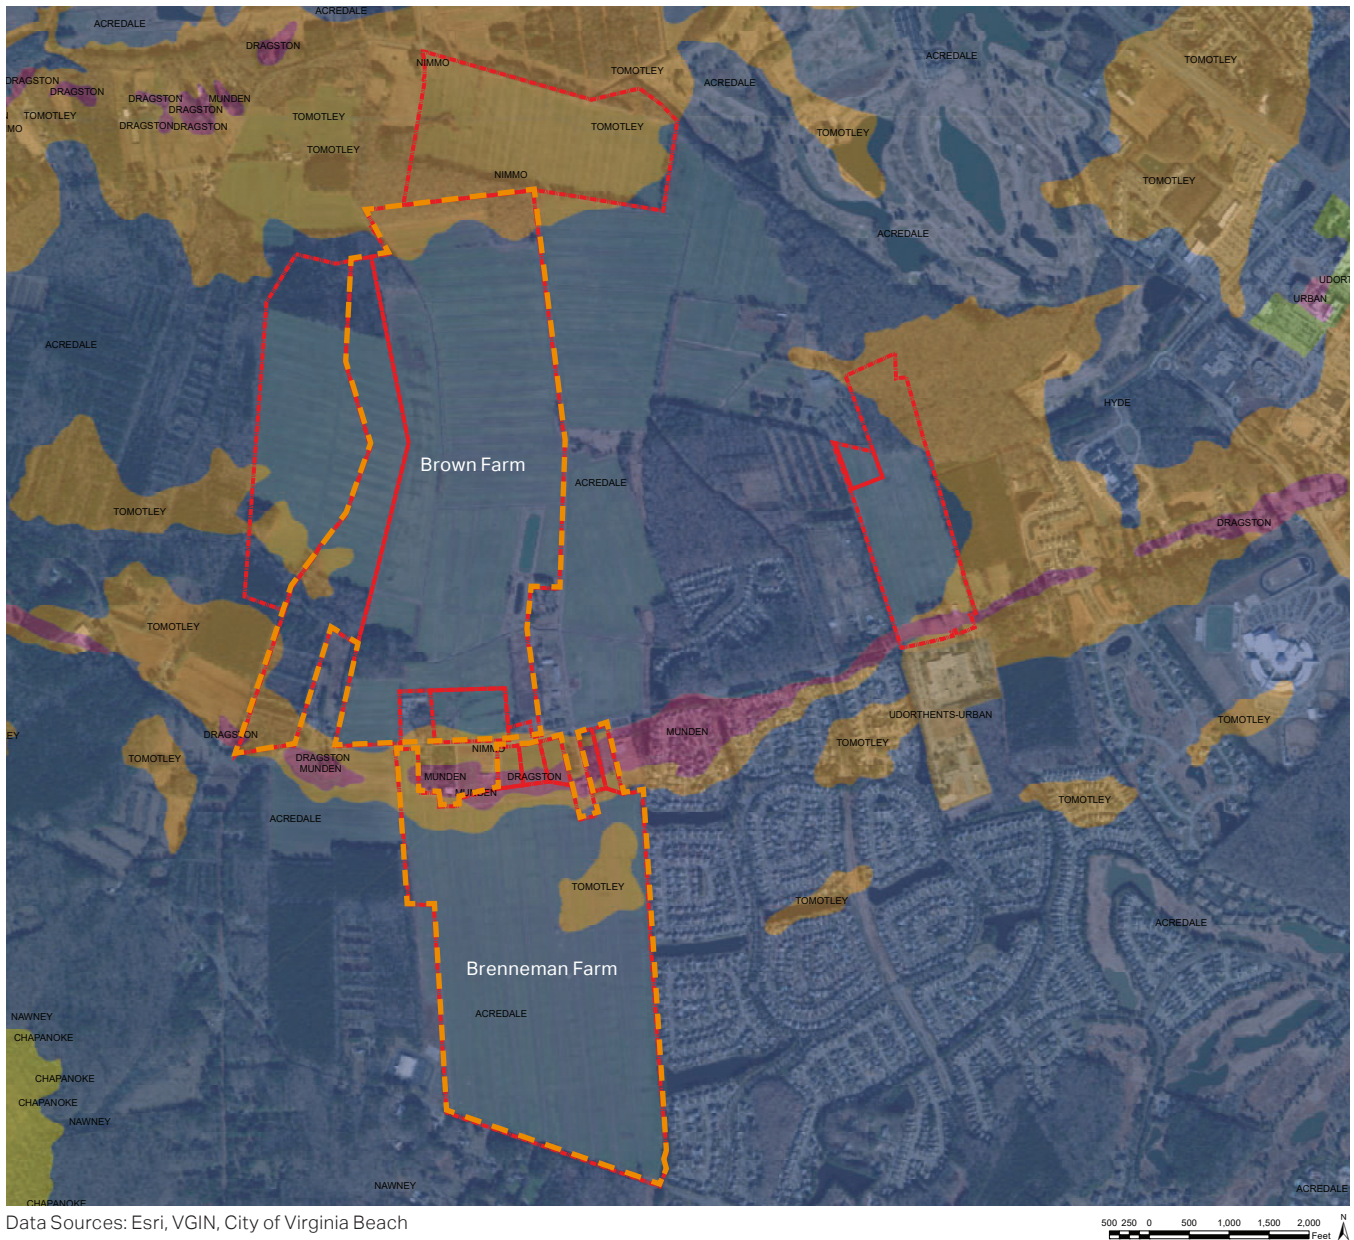
Figure 28. Potential Sites - Soils Map

Both Brenneman Farm and Brown Farm are almost exclusively Acredale soil, a deep and poorly drained soil (Figure 28). Infiltration is slow due to the high silt and clay content of the surface soils. Surface runoff can be very slow, causing ponding after a rain. During the wet season the soil remains saturated, causing rapid runoff during rain events. The soil can be well suited to cultivated crops such as soybeans and corn with the use of drainage ditches like those on site, but crops are occasionally damaged after heavy or long periods of rain. See Appendix C for additional soil data.

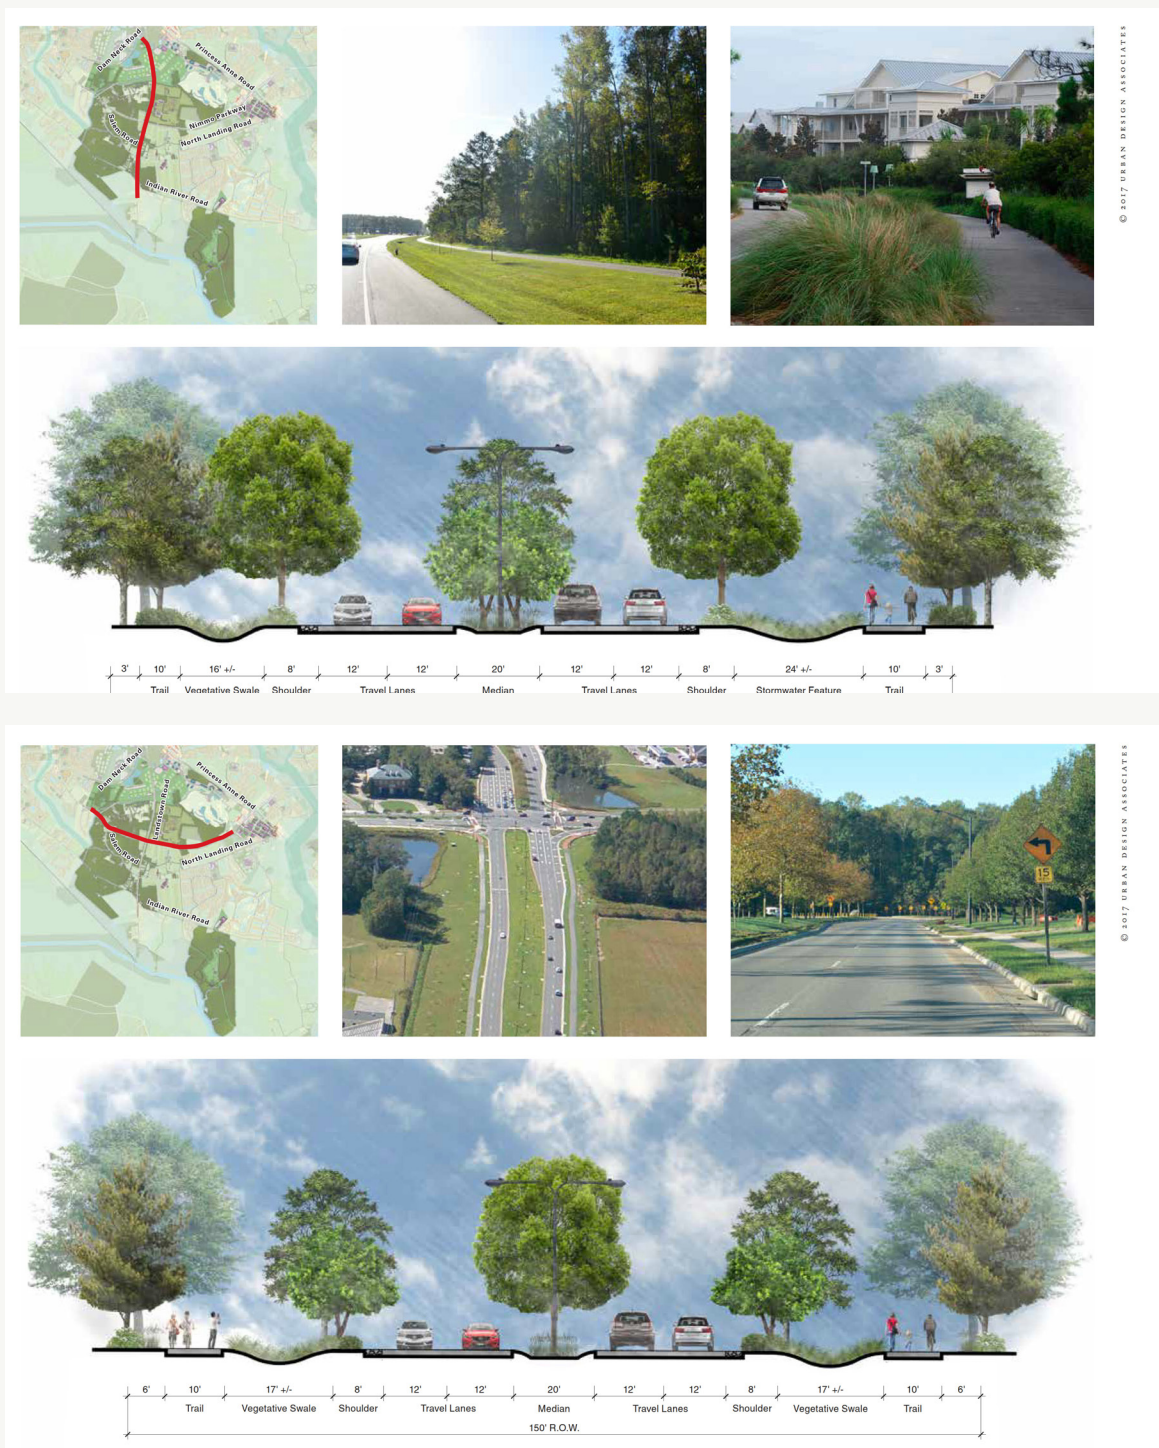
Figure 37. Proposed Landstown Road and Nimmo Parkway Extensions.
 Developed as an amendment to the 2017 Comprehensive Plan, this graphic shows the path of the proposed extensions and provides a typical section of the roadways. Image Credit: Interfacility Traffic Area and Vicinity Master Plan: Virginia Beach, Virginia. 2017.

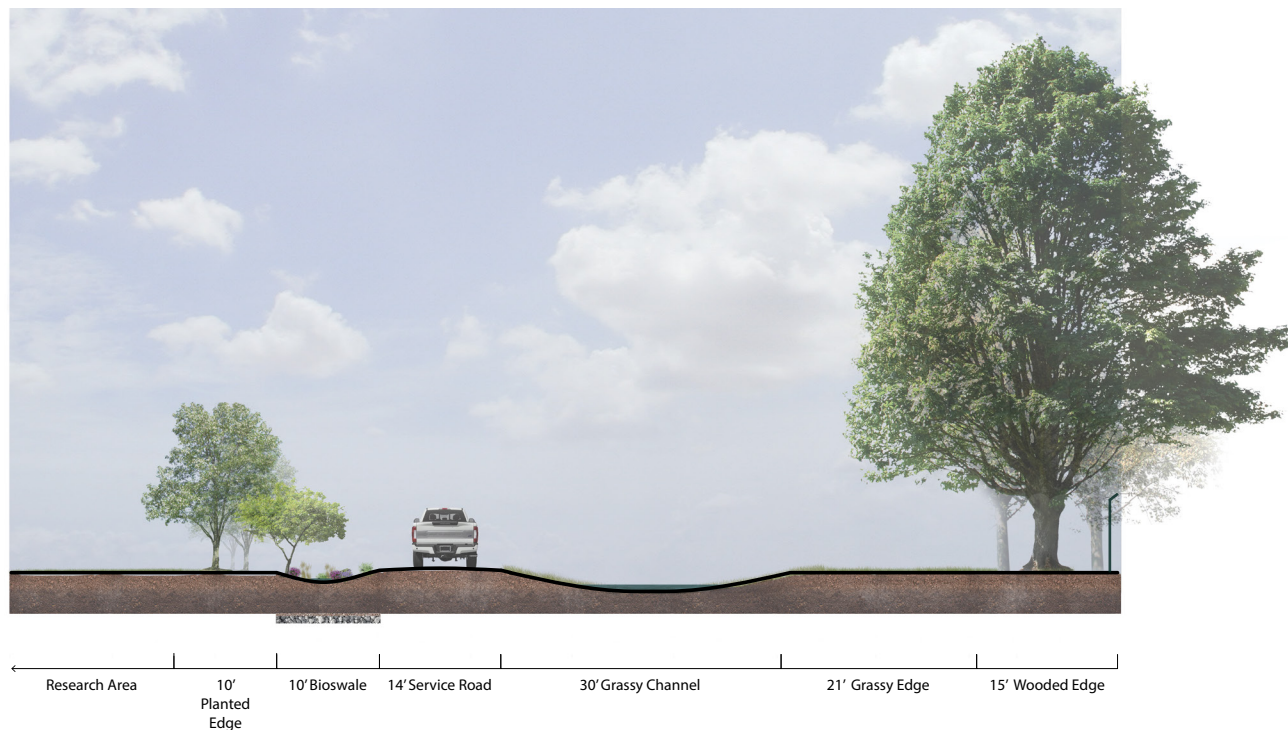
Figure 38. Typical Perimeter Buffer Section.

Brown Farm sites because the poor drainage and extended wetness of the soil would damage or destroy the plants. To recreate the conditions at the current HR AREC and to build an environment in which the research grants could be carried out without damage or loss requires significant site engineering. The soil conditions on site necessitate the addition of thousands of cubic yards of engineered and construction-grade soil.

As discussed on page 36 and detailed in Appendix C, the existing soil conditions at Brenneman and Brown Farm are not suitable to the HR AREC’s needs. The soil composition does not support the varied plant material studied and the soil stays much wetter than the existing HR AREC conditions. Most of the research plant material would not survive directly in the ground at the Brenneman and

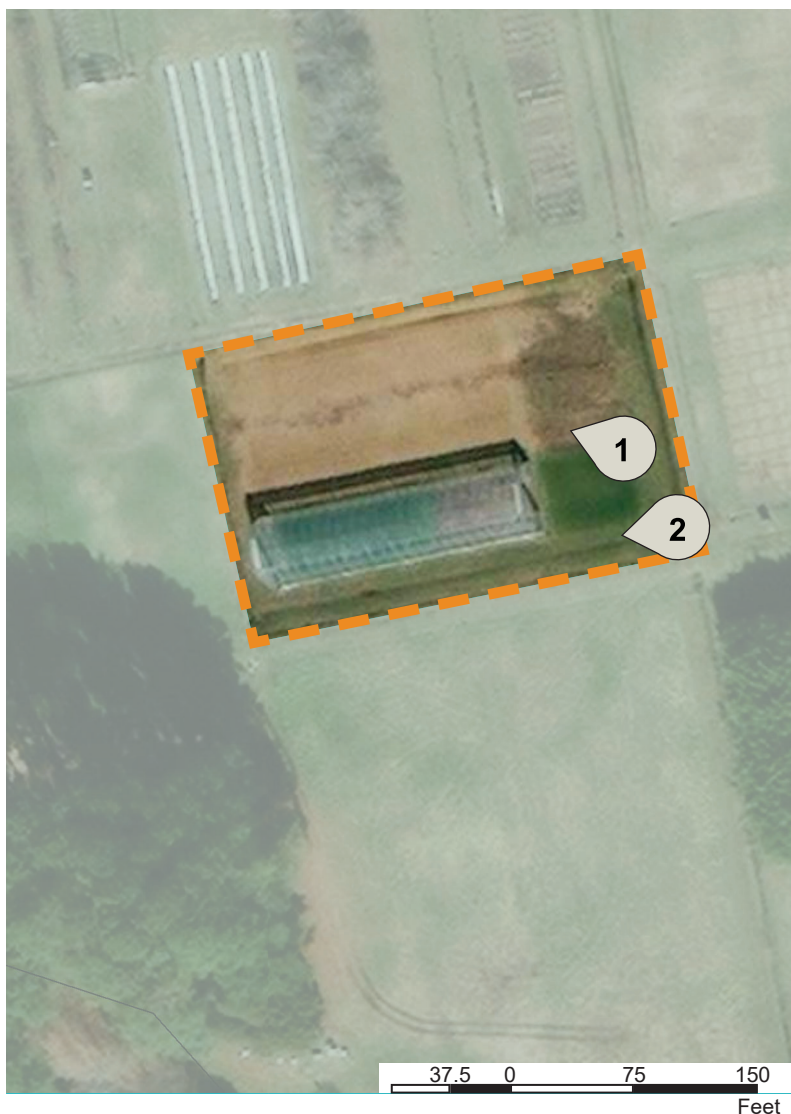
Plat 10 is dedicated to turfgrass research, including drought tolerance. The rain-out shelter creates drought conditions on site, allowing half the plat to be used for water-scarce treatment and the other half to receive field treatment.

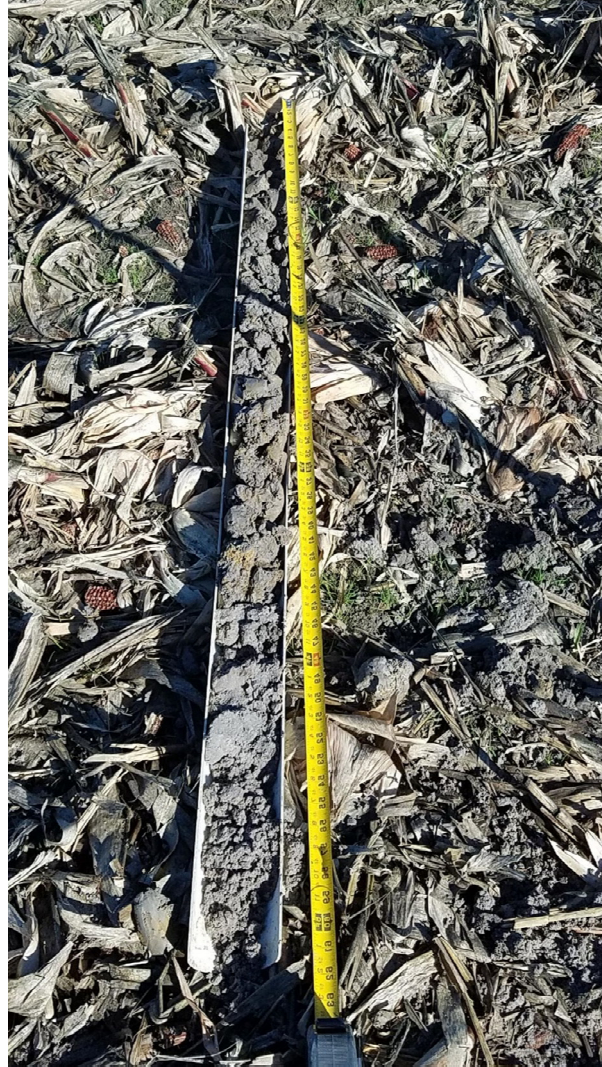
Figure 1. Acredale soil profile bored and evaluated by Daniels & Whitehead on October 6, 2022. Note the dominantly gray (e.g. \leq soil chroma 2) colors throughout indicative of significant saturation for extended periods of time, including the growing season under normal conditions. However, yellowish/red concentrations in the subsoil (Btg horizon) indicate that the water table does fluctuate seasonally to deeper than - 36". These soils are only suitable for intensive agricultural production due to artificial drainage. Silt + clay in the subsoil Btg is high, directly limiting internal permeability.

Acredale is classified as a *Typic Endoaqualf* in USA Soil Taxonomy (NRCS, 2014) based upon the presence of a clay-enriched moderate pH subsoil (Btg horizon) along evidence of seasonal saturation within 12 inches of the surface. The endoaquic soil moisture regime indicates that the elevation of the saturated zone is controlled primarily by the regional water table which falls during the growing season due to plant/crop evapotranspiration (ET) and then rises again in the winter and late spring when precipitation exceeds ET. This seasonal response of the saturated zone is known as the *hydroperiod*, is taken as the difference between the late winter high and late summer lows, and may be as much as 36" or more. However, this discussion of overall soil/site hydrology is simplistic since these soils contain a relatively impermeable subsoil (Btg) horizon that is high in silt+clay and greatly limits downward rates of water movement (Ksat or permeability) such that water commonly "perches" in the Ap (topsoil) horizon for extended periods of time (e.g. days) even when the subsoil remains unsaturated. This was very obvious to us as we traversed the three proposed sites on October 5th and 6th following several days of heavy rain associated with the remnants of Hurricane Ian. We observed near-surface saturated or ponded conditions at dozens of locations across all three properties even though the immediately underlying subsoil was moist, but not saturated.

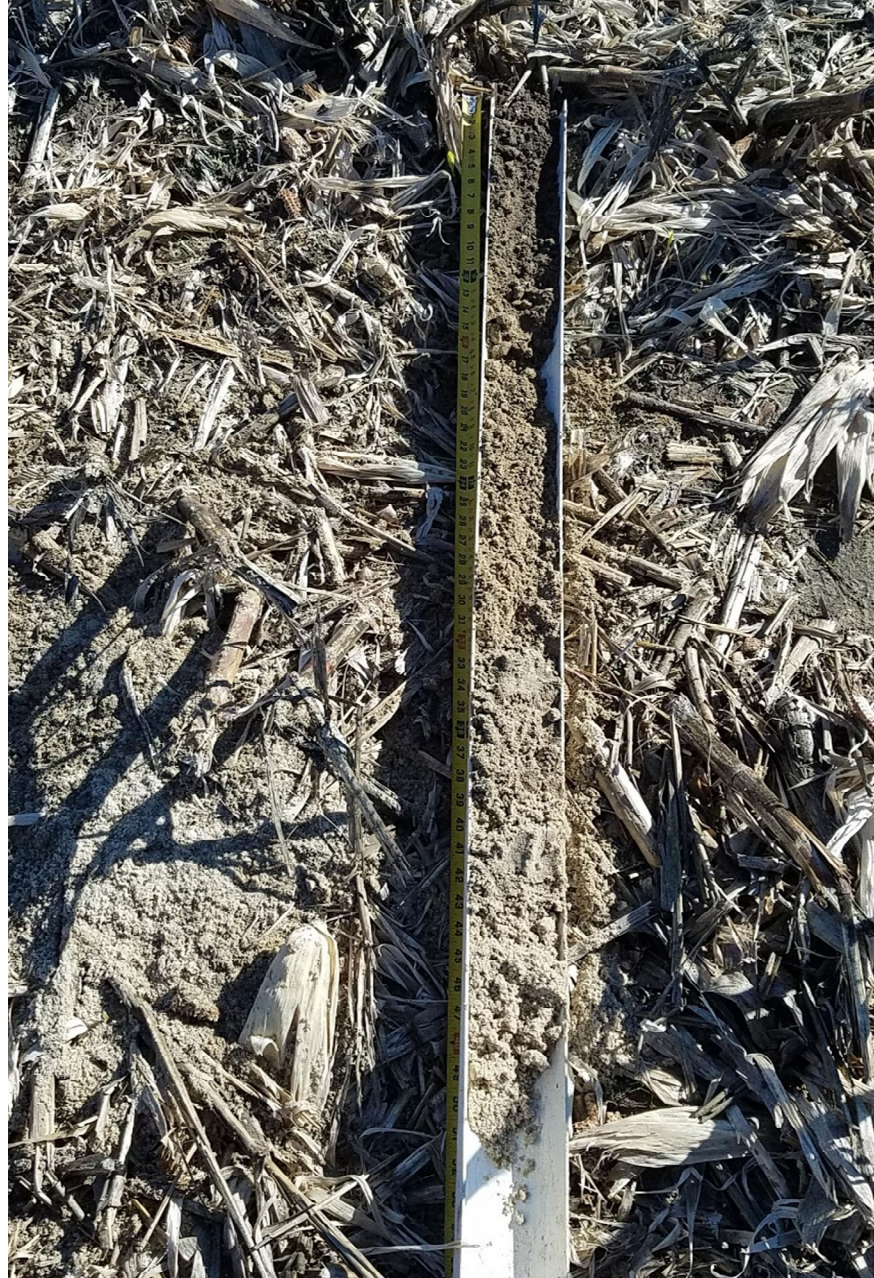
Figure 2. Munden soil profile bored and evaluated by Daniels & Whitehead on October 6, 2022, in the NE corner of the Brenneman tract. Note the “browner” hues in the subsoil down to ~30” indicative of moderately well drained conditions. This profile was much sandier in the subsoil than others we collectively observed over multiple field days.

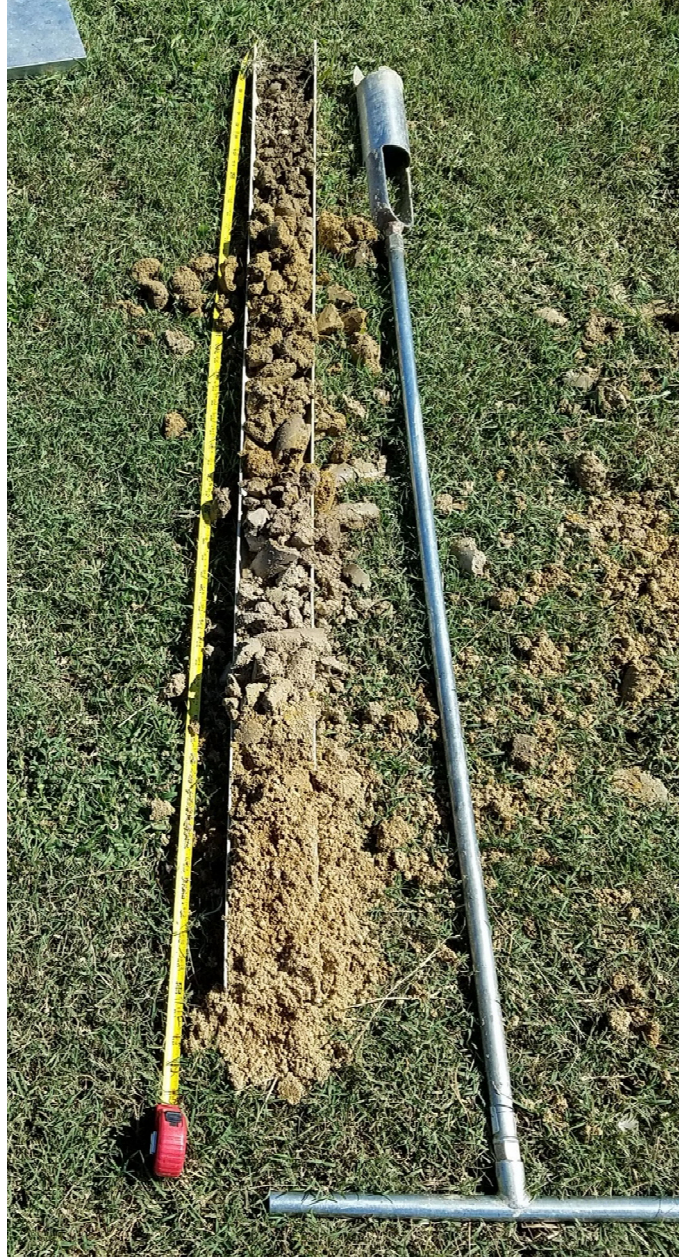
Figure 3. Tetotum soil profile bored and evaluated by Daniels & Whitehead on October 6, 2022, at the HR AREC research plot area. The majority of active research plots at the AREC are located on this moderately well drained soil type moderately well drained conditions with a depth to the seasonally saturated zone of 18 to 30". The auger shown is 60" for comparison.

The dominant soil underlying replicated research plot and demonstration areas at the HR AREC is the Tetotum series (See Appendix A/D/E and Figure 3), which are classified as *Fine-loamy, mixed, semiactive, thermic Aquic Hapludults*. Tetotum is a moderately well drained soil with a typical seasonal high water table of 18 to 30". Due to its better drained landscape position and higher elevation, these soils are more weathered, oxidized and more acidic (lower pH and base saturation) in their underlying Bt horizons than the Acredale soils at the proposed relocation sites. Smaller areas of the well-drained Bojac (See Appendix A/D/E and Figure 4) and State soils are also present in portions of the AREC along with a range of wetter soils including Acredale. The average elevation of the upland portions of the AREC ranges from 18-28 feet AMSL with the better drained soils occurring on more convex and upland local landforms. Due to better internal drainage, the subsoils here (Bt horizons) are better developed with respect to soil structure (aggregation) and are therefore more permeable than the wetter and siltier Acredale soils. Several (n = 3) onsite soil borings (See Appendix D) confirmed the moderately well to well drained nature of these soils and that depth to active redox features was $> 36''$.

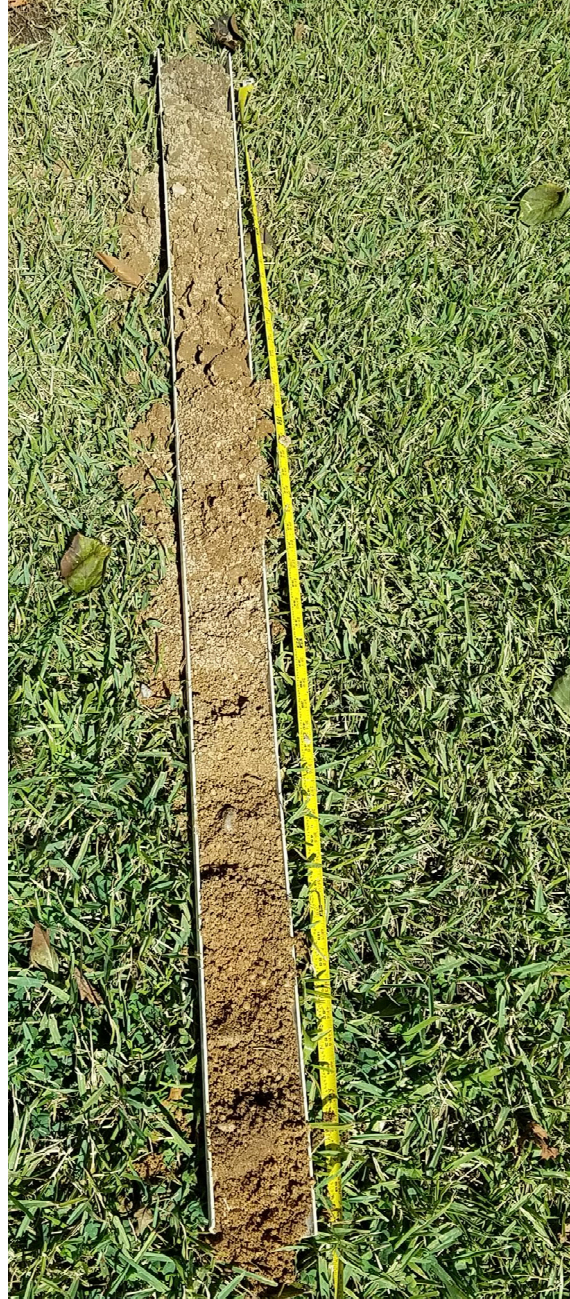
Figure 4. Bojac (or possibly State) soil profile bored and evaluated by Daniels & Whitehead on October 6, 2022, at the HR AREC demonstration garden area. This soil was observed at two locations (see Appendix C), one located next to the local weather station and raised beds area and at a second location pictured here just east of Diamond Springs Road. The soil is well drained with $> 40''$ to seasonal saturation and supports a wide-array of upland plantings in this immediate area and the nearby arboretum. Note: Lighter colored areas in this image were due to the soil drying down in the sun during the description period and were all \geq chroma 3 when excavated moist. The C horizon encountered here at $> 40''$ was a gravelly sand.
